RAIL DEFECTS HEAD CHECKING ON THE SERBIAN RAILWAYS

Zdenka Popović, Ljiljana Brajović, Luka Lazarević, Leposava Milosavljević

Preliminary notes

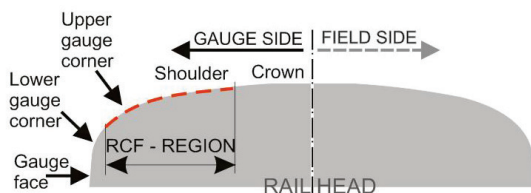
Subject of research in this paper are the HC rail defects on the Serbian Railways. HC appears by default on the outer rail in the curves of radius up to 3000 m. However, most frequently it occurs in the curves of the radius of up to 1500 m, on gauge shoulder and gauge corner. Defect is distinguished exclusively on tracks with a defined motion direction (for example, double track line). The coding system in accordance with the [4] is shown in Tab. 1. The position of HC rail defects on the outer rail head in a curve is shown in Fig. 1.

Figure 1 The characteristic RCF – region at the outer rail head in a curve [15]

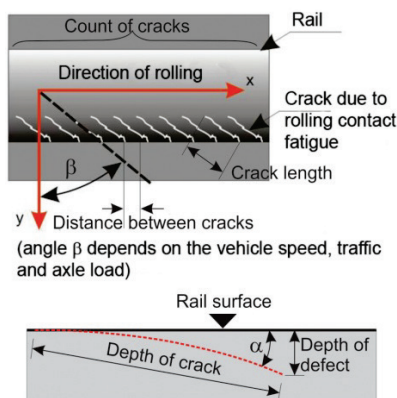
Figure 2 The typical orientation of HC fissures on the rail head [15]

The HC phenomenon is caused by lateral contact force and geometrical spin [11]. It occurs just below the upper surface of the rail head ($\leq 0,1$ mm), progresses rapidly upwards and reaches the upper head surface. Under the traffic load the cracks can be directed down with the risk of multiple rail fractures. The HC defect shows as fine, short, raked, surface fissures at more or less regular distance, which is usually $1 \div 7$ mm (but up to a few centimetres, depending on the rail steel quality). Surface fissures point out the fissures already exist below the surface, extending to certain depth and in certain direction inside the rail head. With increasing rail hardness the spacing between the cracks is reduced [5]. Orientation of HC cracks is shown in Fig. 2 [15]. It is especially dangerous when cracks run in very flat angles of approximately 15° into the rail head and the cracks distance is reduced to 0,5 mm. In this case multiple rail
